Case 274 : Narrative

Case Vehicle (A): 1999 Pontiac	Vehicle (B): 1999 Gillis
Type: Sunfire SE, 2-door coupe	Type: Intercity Bus
Driver: 44-year-old female	Driver: 39-year-old male
CDC: 10-FDEW-1	CDC: 99-0000-0

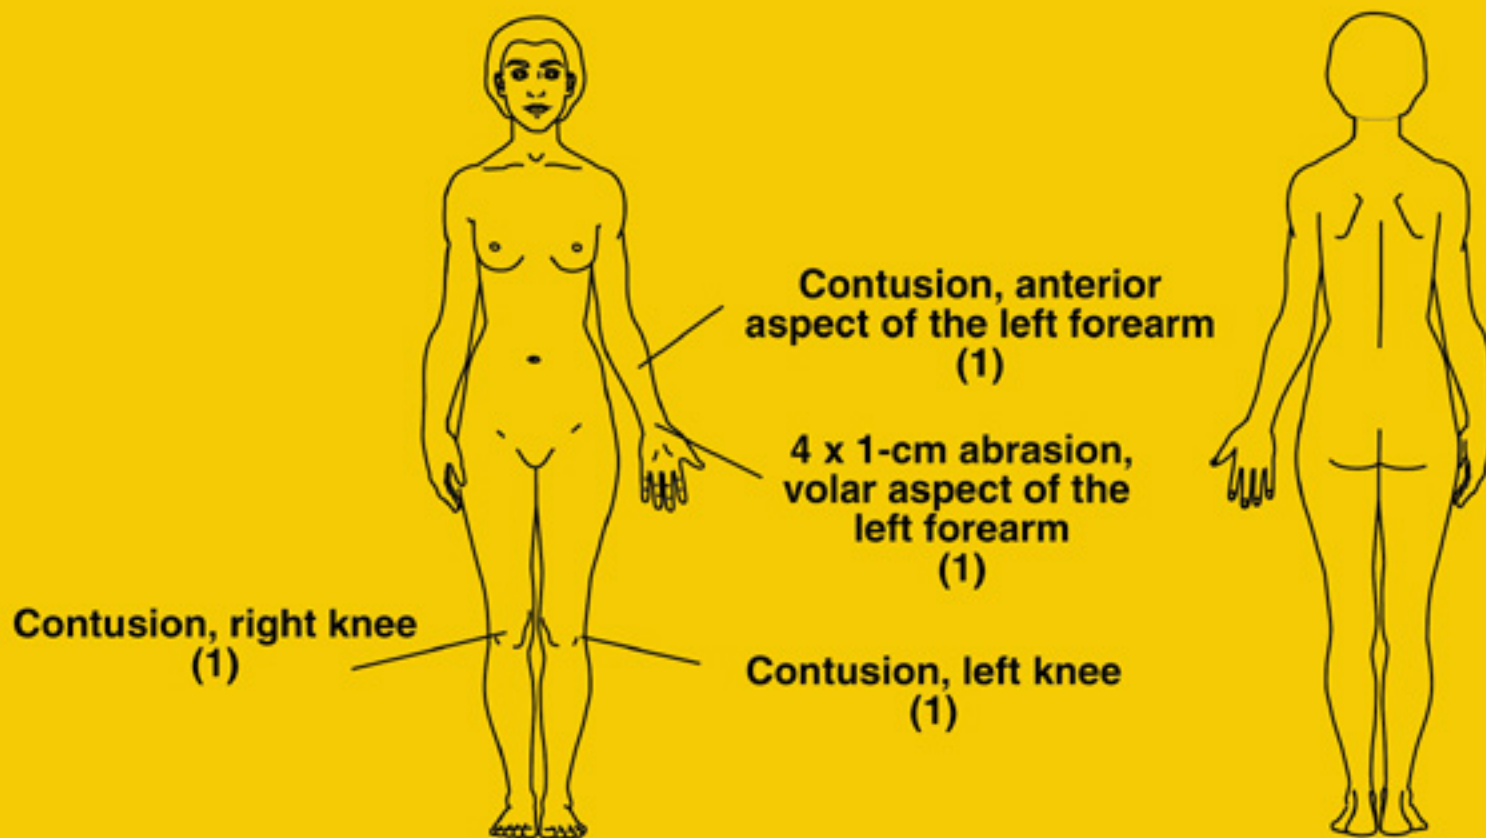
CASE NO.: 274-01

Occupant: Driver	Age: 44 years	Gender: Female		
Restraints: 3-point belt worn; airbag deployed	Stature: 168 cm (5 ft, 6 in)	Mass: 74 kg (162 lb)		
Injury Description	A.I.S.	Injury Source		
—	—	Definite	Probable	Possible
4x1-cm abrasion, volar aspect of the left forearm	1	Airbag	—	—
Contusion, anterior aspect of the left forearm	1	Airbag	—	—
Contusion, left knee	1	Knee bolster	—	—
Contusion, right knee	1	Steering column	—	—
Maximum A.I.S. Level	1	—	—	—
Injury Severity Score	1	—	—	—

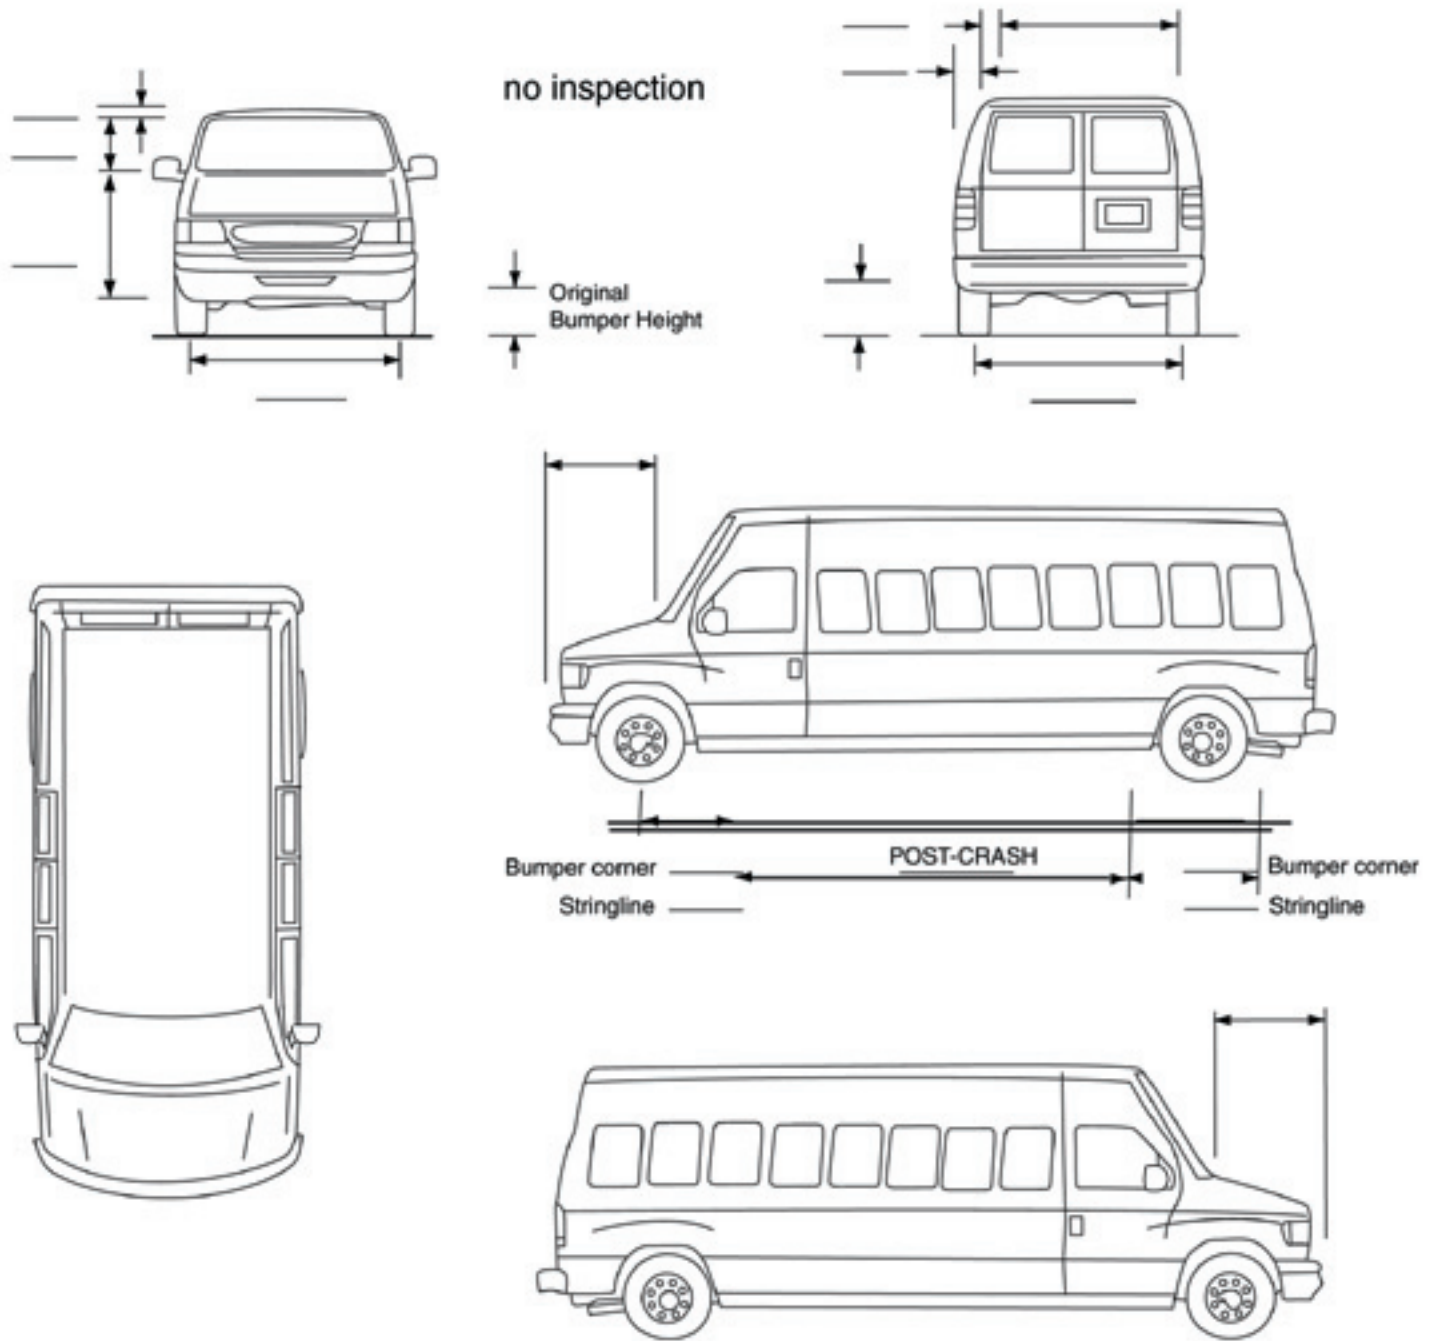
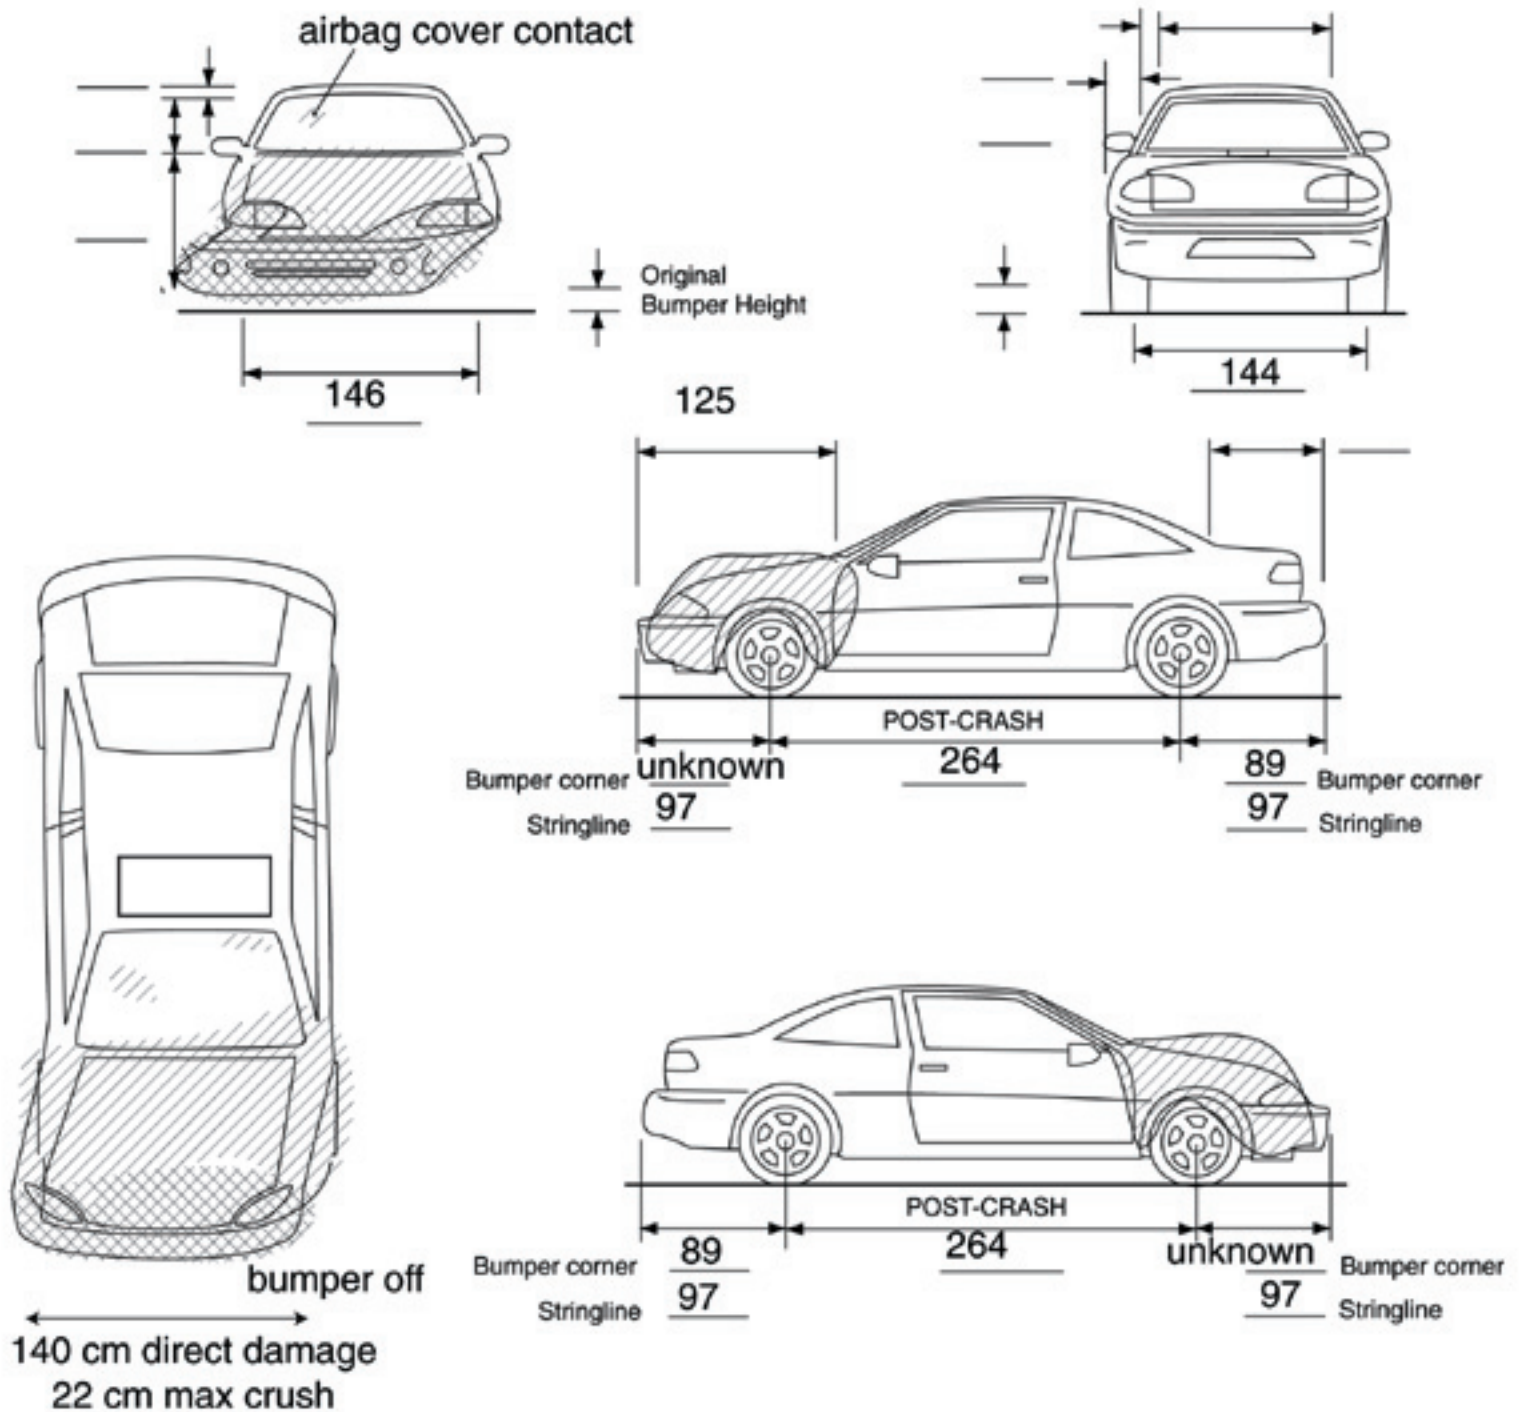
[4](#) [5](#) The direct damage to the front of case vehicle (A) began at the left-front bumper corner and extended 140 cm across the entire front of the vehicle. The maximum crush was approximately 22 cm to the front bumper.

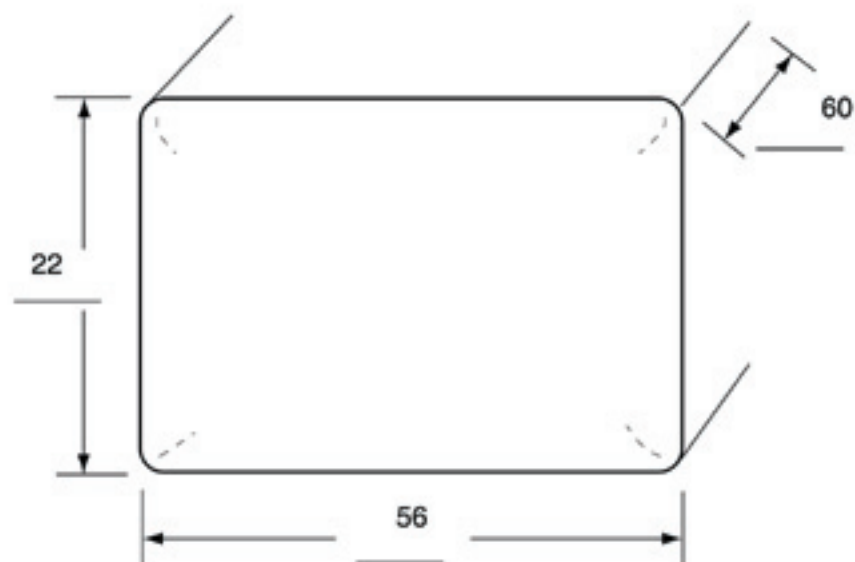
Passenger Airbag Doors

**COVER CONTACTED
AND CRACKED WINDSHIELD**
